**SKB P-22-24**

## **Prototype Repository – Sensor data report**

**Period 2001-09-17 to 2022-01-01**

**Report No 33**

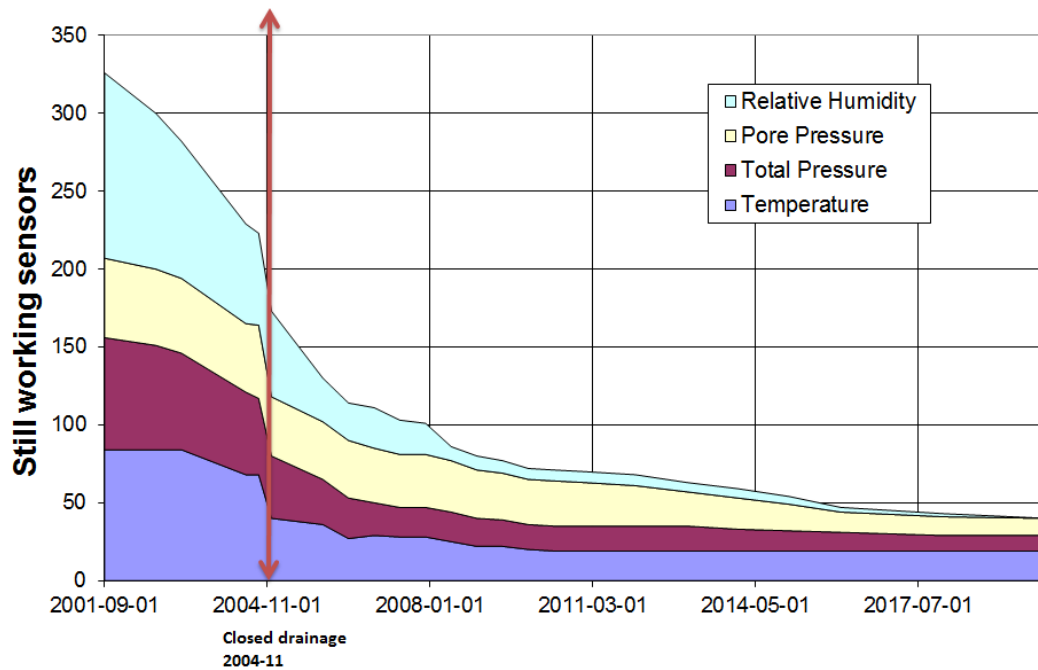
*Figure 5-1 The number of still working sensors placed in the buffer and backfill in Section 1 as function of date. The coloured fields are representing the four types of installed sensors.*

In Figure 5-1 the numbers of still working sensors in the buffer and the backfill of Section 1 are plotted as function of time from September 2001. The figure shows that many of the broken sensors are RH-sensors and thermocouples (in deposition hole). The figure also shows that the numbers of broken sensors increased after the closing of the drainage of the tunnel.

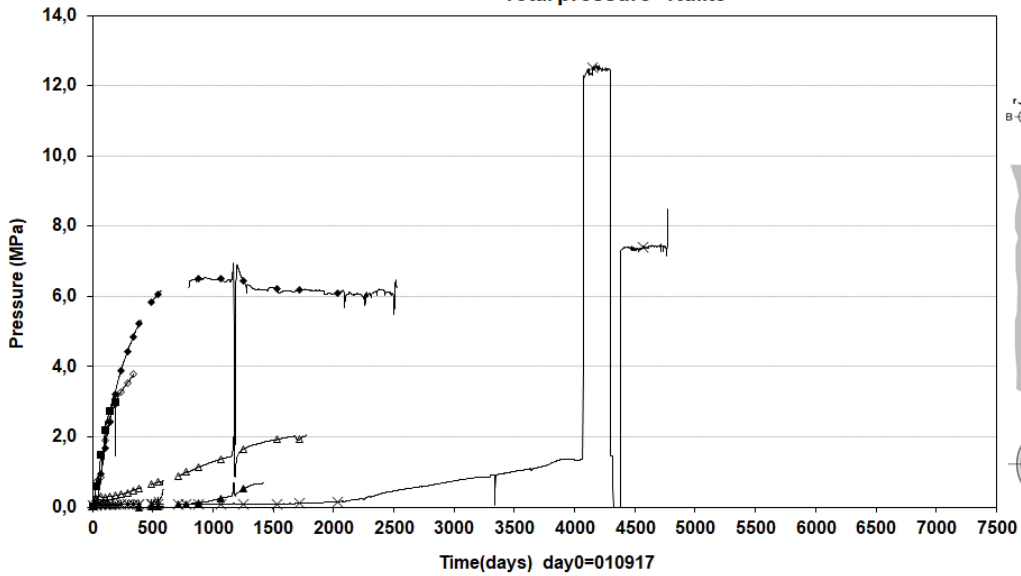
Prototype\ Hole 1 (20010917-20220101)  
Total pressure - Kulite

■ PBU10004(0.504\5°\0.685)	◇ PBU10005(0.504\5°\0.785)	◆ PBU10012(3.030\5°\0.785)	▲ PBU10019(5.558\5°\0.685)
△ PBU10020(5.558\5°\0.785)	× PBU10025(6.317\0°\0.050)	* PBU10027(7.076\0°\0.050)

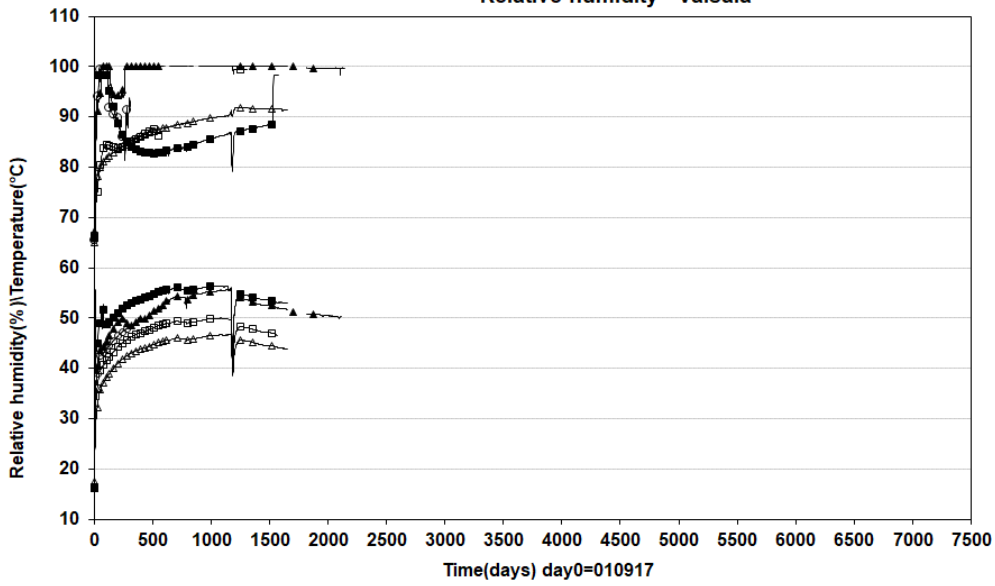
Prototype\Hole 1\Ring10 (20010917-20220101)  
Relative humidity - Vaisala

■ WBU10023(5.428\180°\0.362)	○ WBU10024(5.398\350°\0.585)	□ WBU10025(5.398\350°\0.685)
△ WBU10026(5.398\350°\0.785)	▲ WBU10030(5.398\170°\0.585)

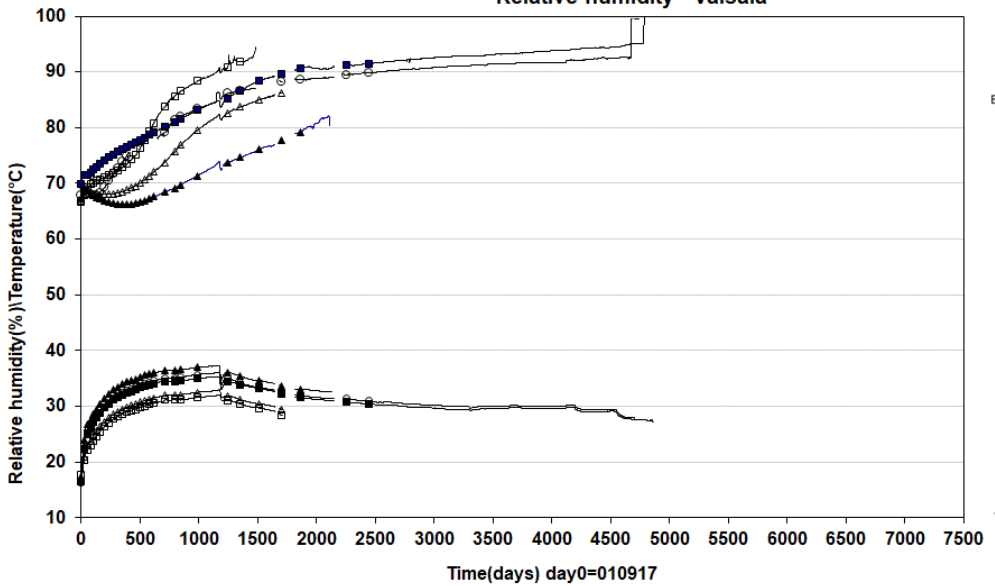
Prototype\Hole 1\Cyl.3 and Cyl.4 (20010917-20220101)  
Relative humidity - Vaisala

▲ WBU10032(6.317\270°\0.050)	■ WBU10033(6.317\350°\0.585)	○ WBU10034(6.317\90°\0.585)
□ WBU10036(6.916\180°\0.050)	△ WBU10037(6.756\270°\0.050)

The sensors placed above the canister (in Cylinder 3 and 4) are indicating that these sensors have reached 100 relative humidity at day 4740. Sixteen sensors are out of order, most of them due to high water saturation of the buffer.

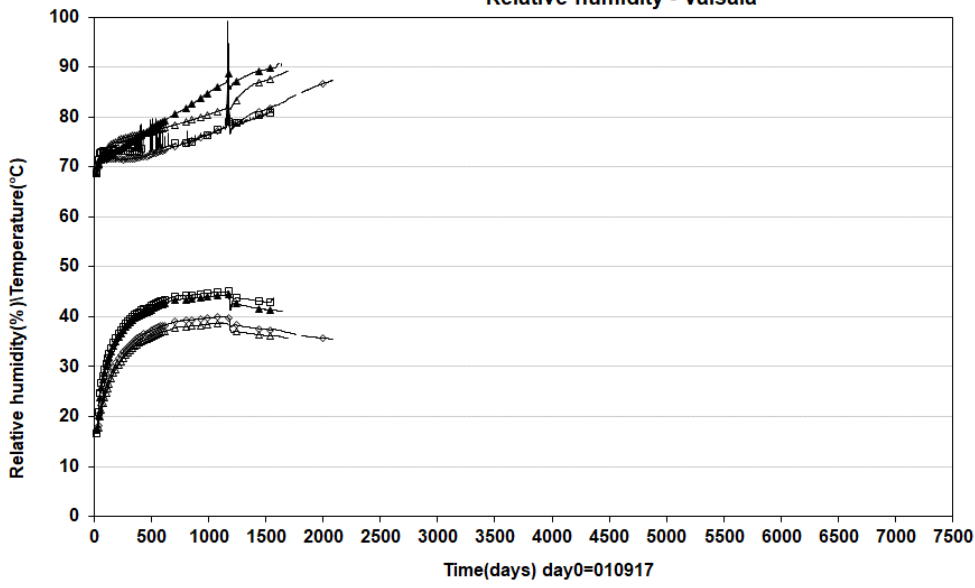
Prototype\Hole 3\Cyl.3 and Cyl.4 (20010917-20220101)  
Relative humidity - Vaisala

□ WBU30032(6.314\180°\0.050)	▲ WBU30033(6.314\350°\0.585)
△ WBU30036(6.680\180°\0.050)	◇ WBU30037(6.840\270°\0.050)

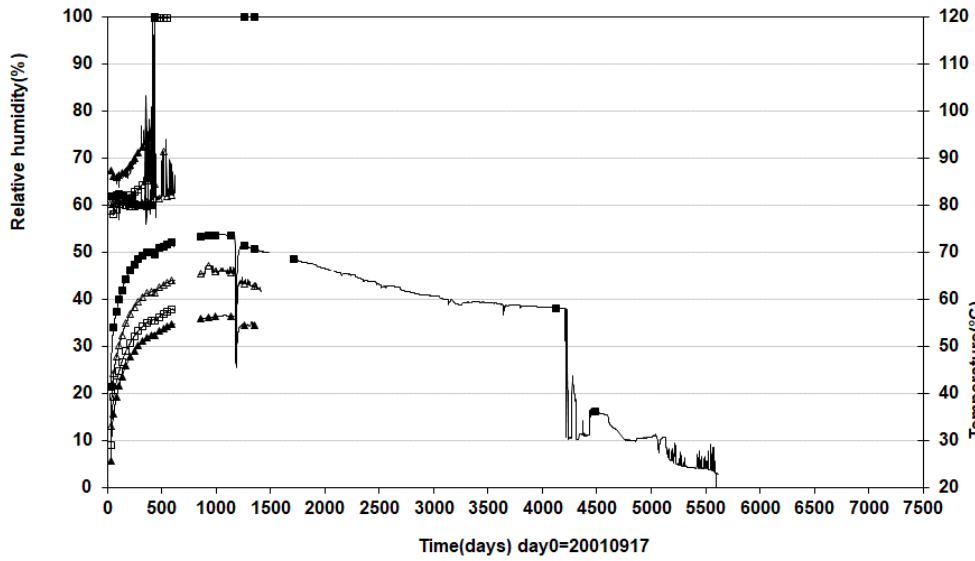
Prototype\Hole 3\Cyl.1 (20010917-20220101)  
Relative humidity - Rotronic

□ WBU30001(0.045\180°\0.050)	△ WBU30002(0.215\0°\0.400)
■ WBU30003(0.245\180°\0.100)	▲ WBU30008(0.245\80°\0.685)

All Rotronic sensors in hole 3 have failed or increased the measured RH to 100 %. The reason for this is unclear. Since there are no other signs of strong wetting, malfunction is more probable than strong wetting. One sensor (WBU30016) placed close to the canister in block R5 was indicating a drying of the bentonite until it failed.

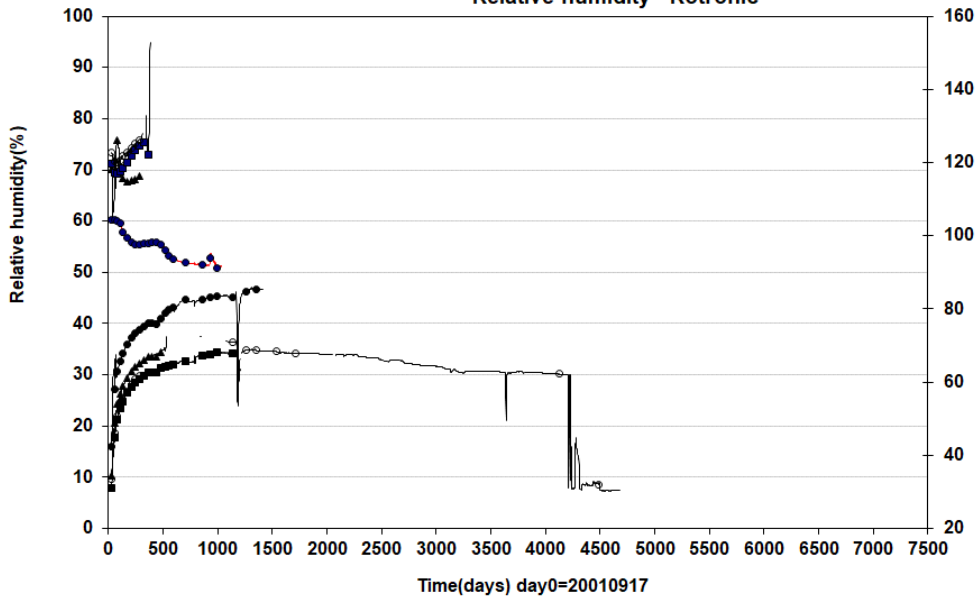
Prototype\Hole 3\Ring 5 (20010917-20220101)  
Relative humidity - Rotronic

● WBU30016(2.750\180°\0.535)    ▲ WBU30017(2.750\180°\0.685)  
■ WBU30018(2.750\180°\0.785)    ○ WBU30021(2.750\180°\0.785)

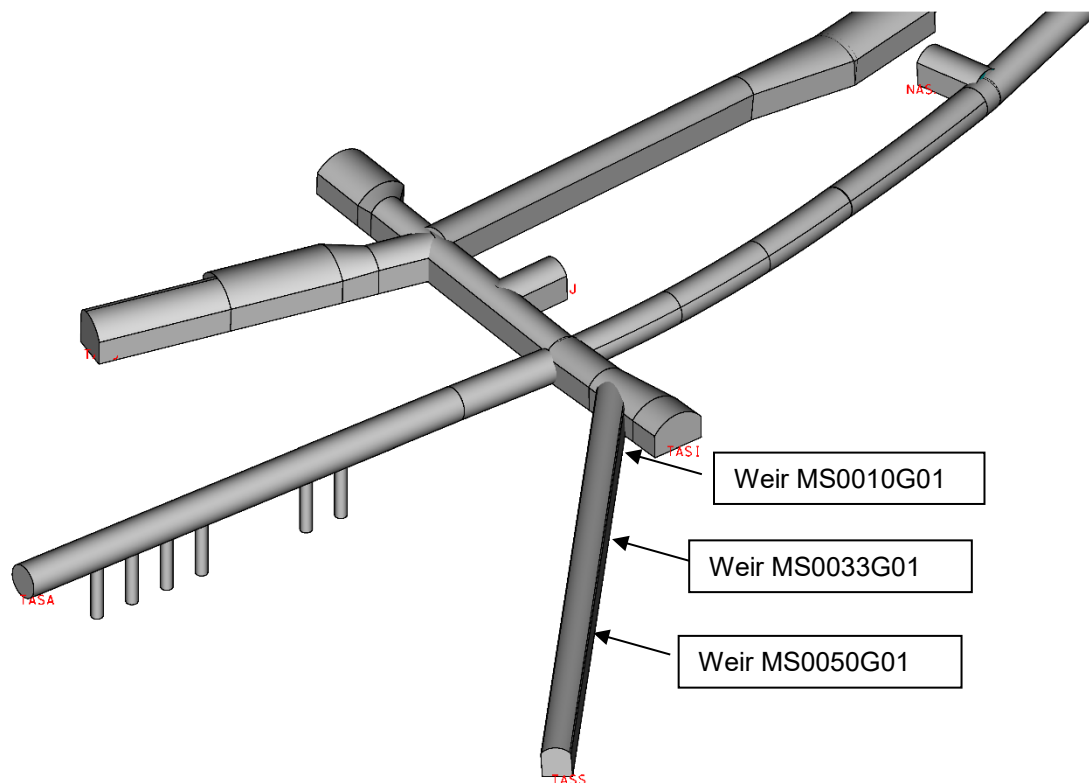
*Figure A5-0-3 The tunnel-system including the TASS-tunnel with indication of the weir locations in TASS.*

Three weirs are located within the TASS-tunnel and their locations are shown in Figure A5-3 below, measuring the flow into sections 10–33 m, 33–50 m and 50–80.7 m respectively.

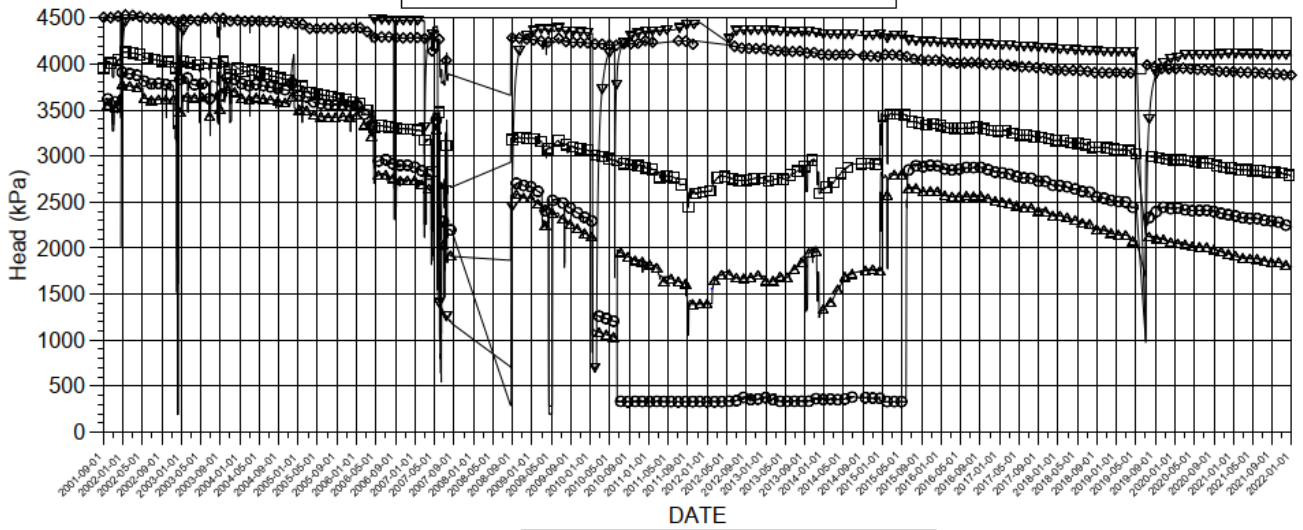
### KA3510A PRESSURE HEAD

- Events**
- Start backfilling of section I 2001-09-03
  - Stop backfilling of section I 2001-11-20
  - Casting of inner plug finalized 2001-12-19
  - Start backfilling of section II 2003-04-29
  - Stop backfilling of section II 2003-06-27
  - Casting of outer plug finalized 2003-09-11
  - Packer failure of KA3573A:3 2006-04-18
  - Start drilling of Fine Sealing Project 2007-03-12
  - Start grouting of Fine Sealing Project 2007-11-19
  - Excavation start of TASS tunnel 2007-12-11
  - Excavation stop of TASS tunnel 2008-12-18
  - Demolition work start Section II December 2010
  - Demolition work Section II finalized 2011-12-15
  - Replacement of packers Section II December 2014

- Borehole sections**
- ▽ A:1 125 m - 150 m
  - ◇ A:2 110 m - 124 m
  - A:3 75 m - 109 m
  - A:4 51 m - 74 m
  - ▲ A:5 4.5 m - 50 m

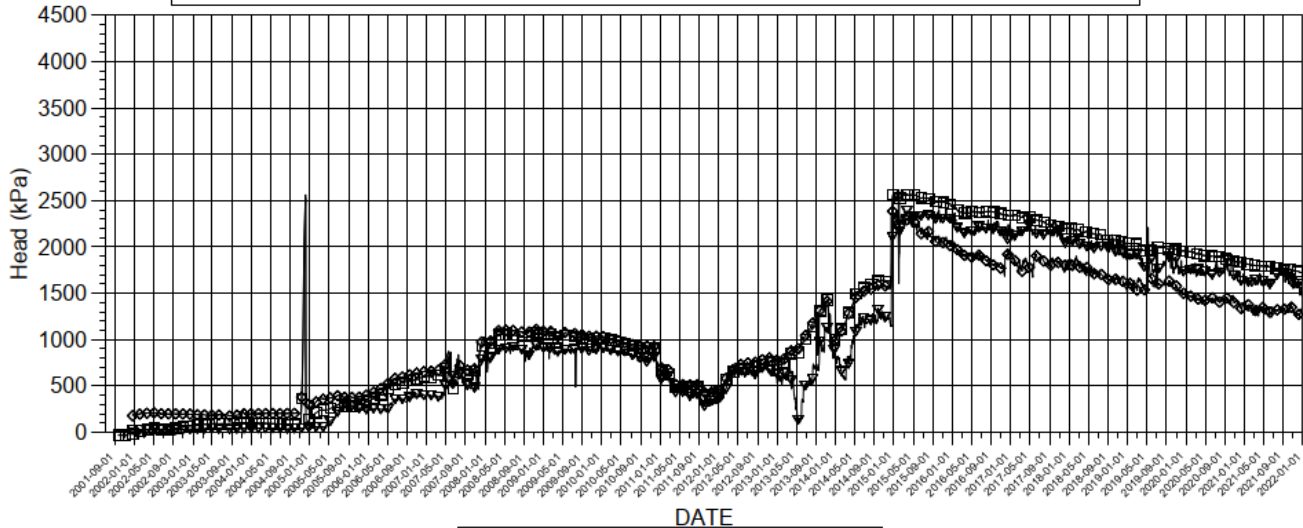
### KA3563A01, KA3563D01, KA3563I01 PRESSURE HEAD

- Events**
- Start backfilling of section I 2001-09-03
  - Stop backfilling of section I 2001-11-20
  - Casting of inner plug finalized 2001-12-19
  - Start backfilling of section II 2003-04-29
  - Stop backfilling of section II 2003-06-27
  - Casting of outer plug finalized 2003-09-11
  - Packer failure of KA3573A:3 2006-04-18
  - Start drilling of Fine Sealing Project 2007-03-12
  - Start grouting of Fine Sealing Project 2007-11-19
  - Excavation start of TASS tunnel 2007-12-11
  - Excavation stop of TASS tunnel 2008-12-18
  - Demolition work start Section II December 2010
  - Demolition work Section II finalized 2011-12-15
  - Replacement of packers Section II December 2014

- Borehole sections**
- ▽ KA3563A01:1 0.65 m - 2 m
  - ◇ KA3563D01:1 0.65 m - 2 m
  - KA3563I01:1 0.65 m - 2 m

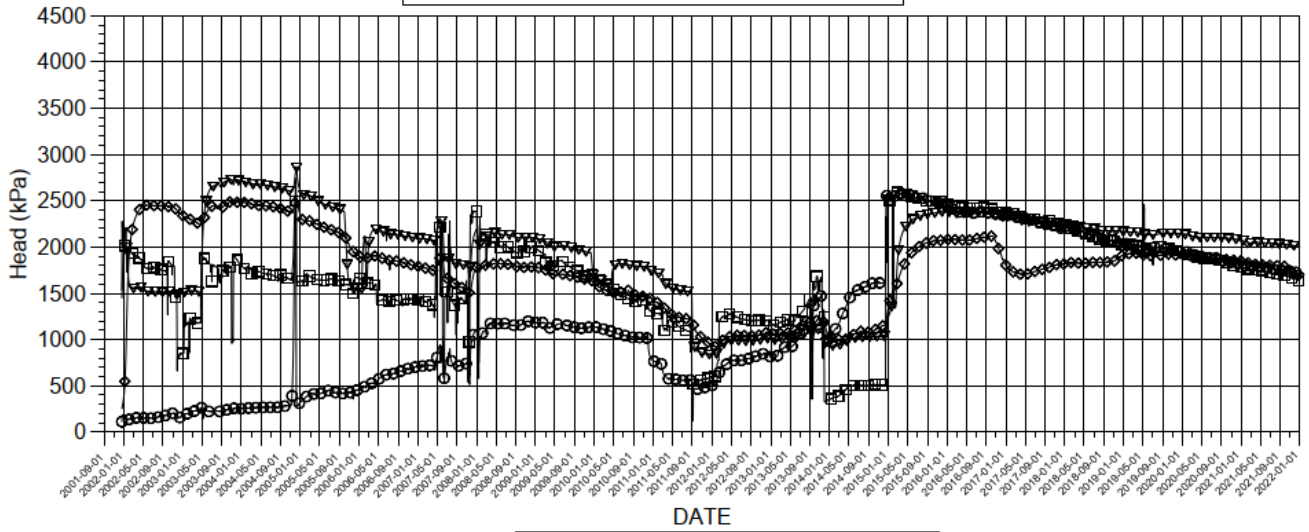
### KA3563G PRESSURE HEAD

- Events**
- Start backfilling of section I 2001-09-03
  - Stop backfilling of section I 2001-11-20
  - Casting of inner plug finalized 2001-12-19
  - Start backfilling of section II 2003-04-29
  - Stop backfilling of section II 2003-06-27
  - Casting of outer plug finalized 2003-09-11
  - Packer failure of KA3573A:3 2006-04-18
  - Start drilling of Fine Sealing Project 2007-03-12
  - Start grouting of Fine Sealing Project 2007-11-19
  - Excavation start of TASS tunnel 2007-12-11
  - Excavation stop of TASS tunnel 2008-12-18
  - Demolition work start Section II December 2010
  - Demolition work Section II finalized 2011-12-15
  - Replacement of packers Section II December 2014

- Borehole sections**
- ▽ G:1 15 m - 30 m
  - ◇ G:2 10 m - 13 m
  - G:3 4 m - 8 m
  - G:4 1.5 m - 3 m

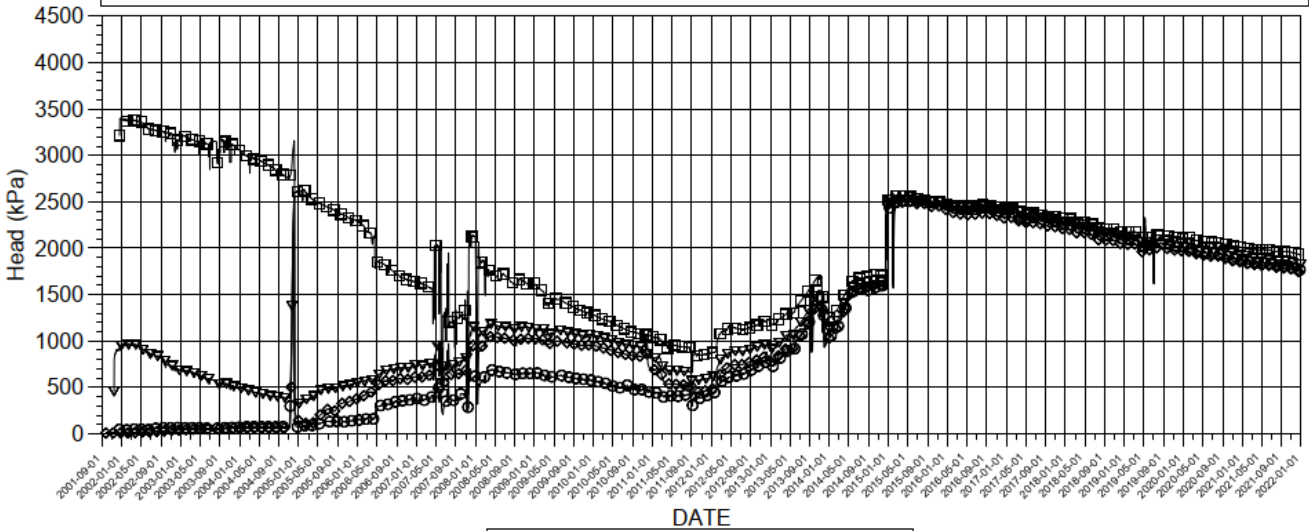
### KA3566C01, KA3568D01, KA3573C01, KA3574D01 PRESSURE HEAD

- Events**
- Start backfilling of section I 2001-09-03
  - Stop backfilling of section I 2001-11-20
  - Casting of inner plug finalized 2001-12-19
  - Start backfilling of section II 2003-04-29
  - Stop backfilling of section II 2003-06-27
  - Casting of outer plug finalized 2003-09-11
  - Packer failure of KA3573A:3 2006-04-18
  - Start drilling of Fine Sealing Project 2007-03-12
  - Start grouting of Fine Sealing Project 2007-11-19
  - Excavation start of TASS tunnel 2007-12-11
  - Excavation stop of TASS tunnel 2008-12-18
  - Demolition work start Section II December 2010
  - Demolition work Section II finalized 2011-12-15
  - Replacement of packers Section II December 2014

- Borehole sections**
- ▽ KA3566C01:1 0.65 m - 2 m
  - ◇ KA3568D01:1 0.65 m - 2 m
  - KA3573C01:1 0.65 m - 2 m
  - KA3574D01:1 0.65 m - 2 m

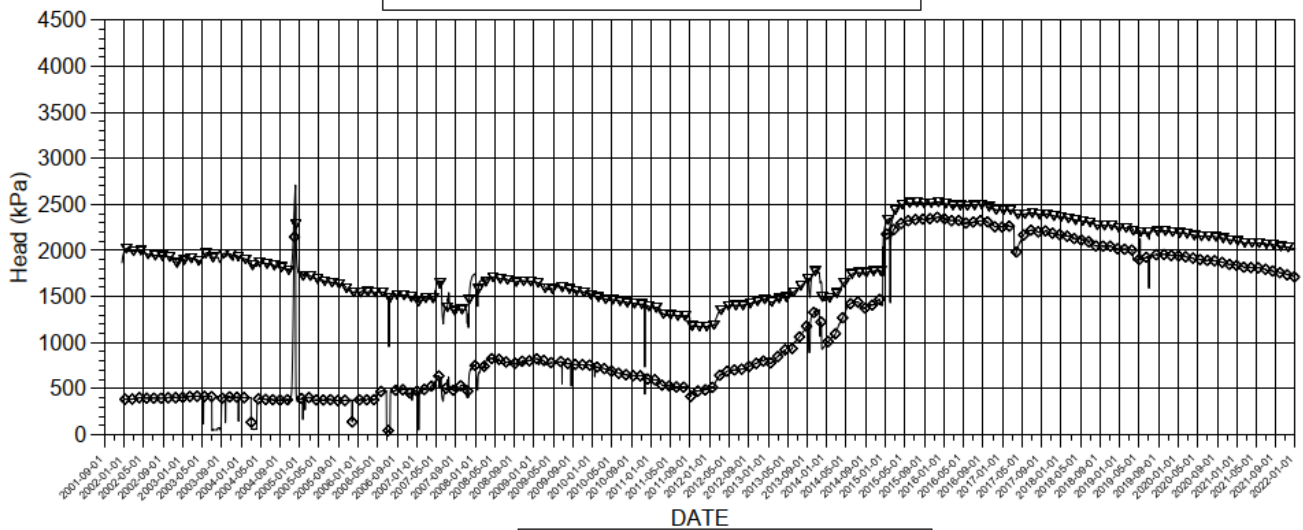
### KA3572G01 PRESSURE HEAD

- Events**
- Start backfilling of section I 2001-09-03
  - Stop backfilling of section I 2001-11-20
  - Casting of inner plug finalized 2001-12-19
  - Start backfilling of section II 2003-04-29
  - Stop backfilling of section II 2003-06-27
  - Casting of outer plug finalized 2003-09-11
  - Packer failure of KA3573A:3 2006-04-18
  - Start drilling of Fine Sealing Project 2007-03-12
  - Start grouting of Fine Sealing Project 2007-11-19
  - Excavation start of TASS tunnel 2007-12-11
  - Excavation stop of TASS tunnel 2008-12-18
  - Demolition work start Section II December 2010
  - Demolition work Section II finalized 2011-12-15
  - Replacement of packers Section II December 2014

- Borehole sections**
- ▼ G01:1 7.3 m - 12.0 m
  - ◆ G01:2 2.7 m - 5.3 m

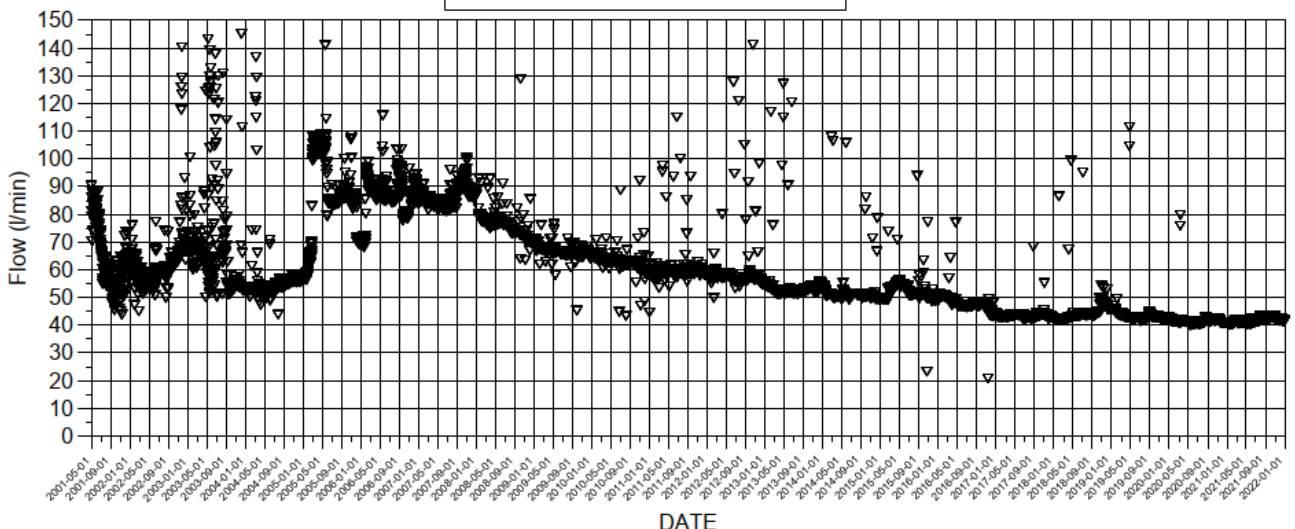
### MA3411G WEIR FLOW

- Events**
- Start backfilling of section I 2001-09-03
  - Stop backfilling of section I 2001-11-20
  - Casting of inner plug finalized 2001-12-19
  - Start backfilling of section II 2003-04-29
  - Stop backfilling of section II 2003-06-27
  - Casting of outer plug finalized 2003-09-11
  - Packer failure of KA3573A:3 2006-04-18
  - Start drilling of Fine Sealing Project 2007-03-12
  - Start grouting of Fine Sealing Project 2007-11-19
  - Excavation start of TASS tunnel 2007-12-11
  - Excavation stop of TASS tunnel 2008-12-18
  - Demolition work start Section II December 2010
  - Demolition work Section II finalized 2011-12-15
  - Replacement of packers Section II December 2014

- ▽ WEIR MA3411G

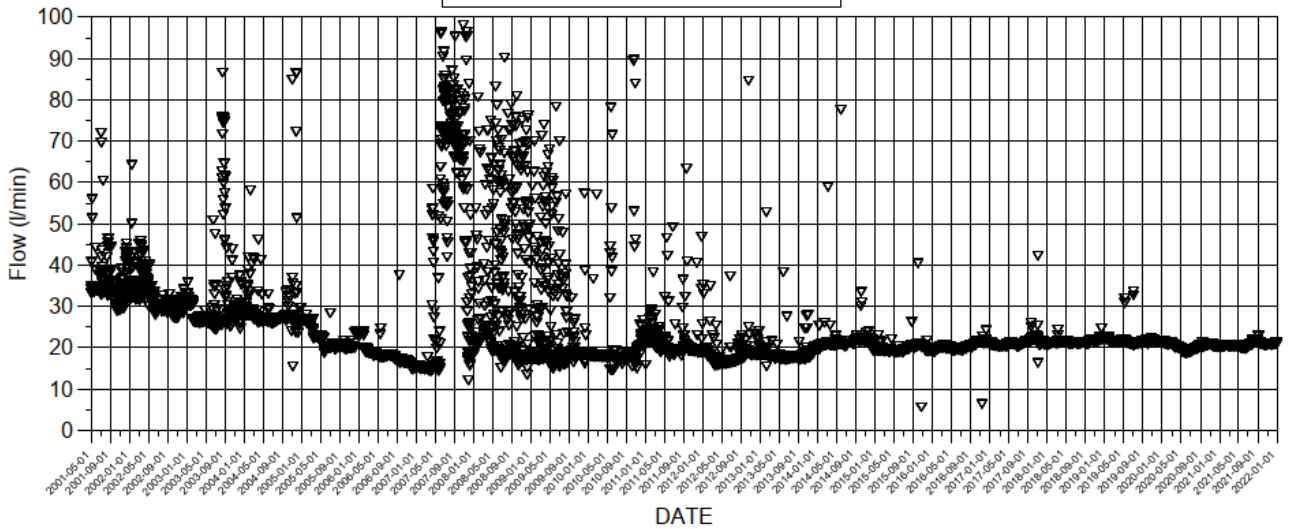
### MA3426G WEIR FLOW

- Events**
- Start backfilling of section I 2001-09-03
  - Stop backfilling of section I 2001-11-20
  - Casting of inner plug finalized 2001-12-19
  - Start backfilling of section II 2003-04-29
  - Stop backfilling of section II 2003-06-27
  - Casting of outer plug finalized 2003-09-11
  - Packer failure of KA3573A:3 2006-04-18
  - Start drilling of Fine Sealing Project 2007-03-12
  - Start grouting of Fine Sealing Project 2007-11-19
  - Excavation start of TASS tunnel 2007-12-11
  - Excavation stop of TASS tunnel 2008-12-18
  - Demolition work start Section II December 2010
  - Demolition work Section II finalized 2011-12-15
  - Replacement of packers Section II December 2014

▽ WEIR MA3426G

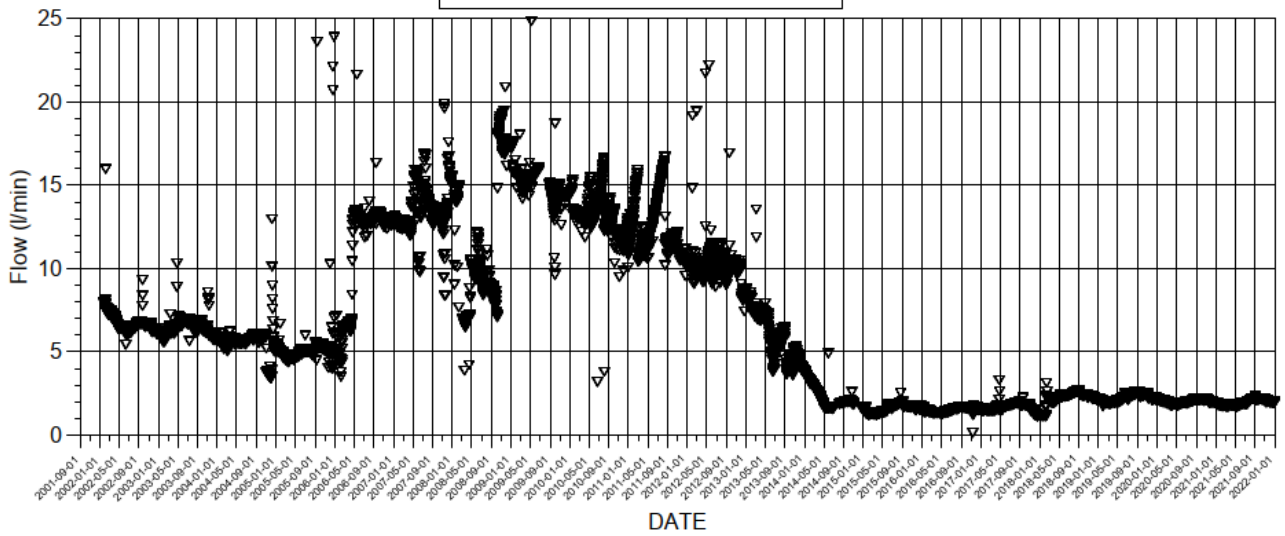
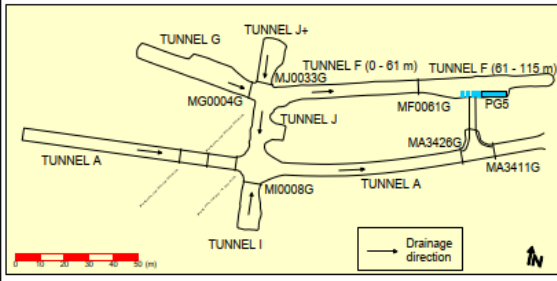
### MG0004G WEIR FLOW

- Events**
- Start backfilling of section I 2001-09-03
  - Stop backfilling of section I 2001-11-20
  - Casting of inner plug finalized 2001-12-19
  - Start backfilling of section II 2003-04-29
  - Stop backfilling of section II 2003-06-27
  - Casting of outer plug finalized 2003-09-11
  - Packer failure of KA3573A:3 2006-04-18
  - Start drilling of Fine Sealing Project 2007-03-12
  - Start grouting of Fine Sealing Project 2007-11-19
  - Excavation start of TASS tunnel 2007-12-11
  - Excavation stop of TASS tunnel 2008-12-18
  - Demolition work start Section II December 2010
  - Demolition work Section II finalized 2011-12-15
  - Replacement of packers Section II December 2014

▽ WEIR MG0004G

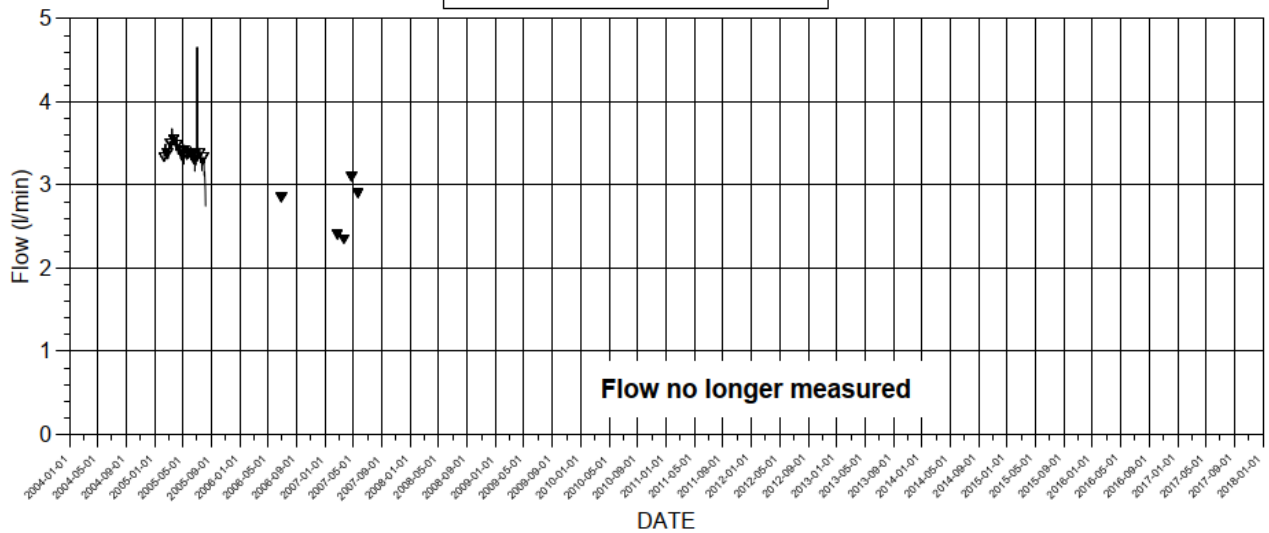
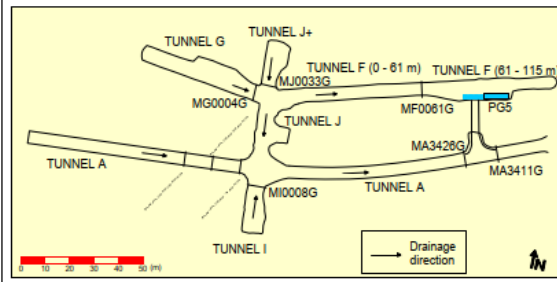
### MI0008G WEIR FLOW

- Events**
- Start backfilling of section I 2001-09-03
  - Stop backfilling of section I 2001-11-20
  - Casting of inner plug finalized 2001-12-19
  - Start backfilling of section II 2003-04-29
  - Stop backfilling of section II 2003-06-27
  - Casting of outer plug finalized 2003-09-11
  - Packer failure of KA3573A:3 2006-04-18
  - Start drilling of Fine Sealing Project 2007-03-12
  - Start grouting of Fine Sealing Project 2007-11-19
  - Excavation start of TASS tunnel 2007-12-11
  - Excavation stop of TASS tunnel 2008-12-18
  - Demolition work start Section II December 2010
  - Demolition work Section II finalized 2011-12-15

▽ WEIR MI0008G  
 ▼ Manual readings
